PB91-916501
NTSB/PAR-91/01

PIPELINE ACCIDENT REPORT

LIQUID PROPANE PIPELINE RUPTURE AND FIRE
TEXAS EASTERN PRODUCTS PIPELINE COMPANY
NORTH BLENHEIM, NEW YORK
MARCH 13, 1990

ADOPTED: JUNE 11, 1991

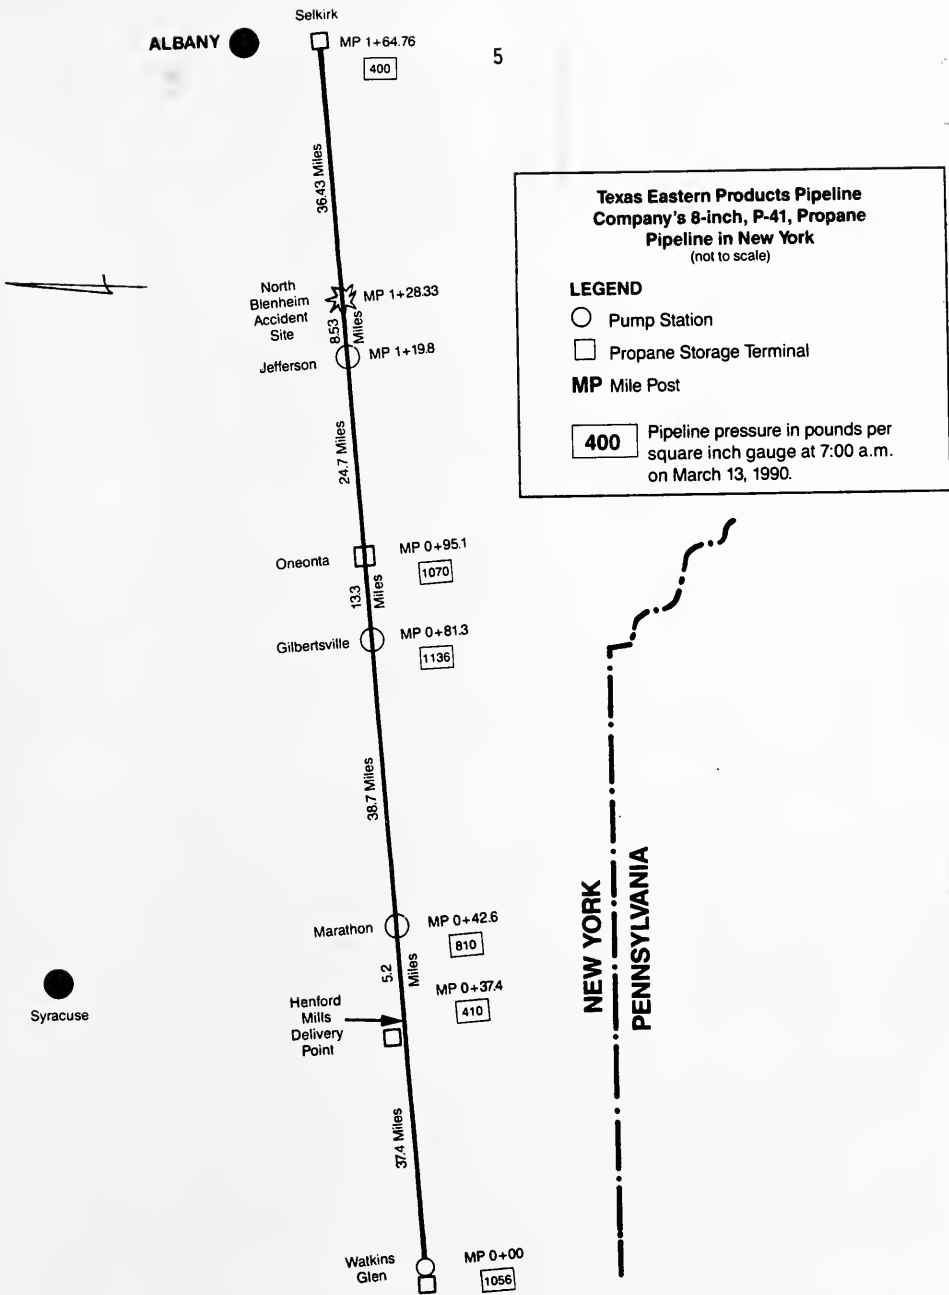
Figure 2.--Schematic of line P-41 showing pump stations and terminals.

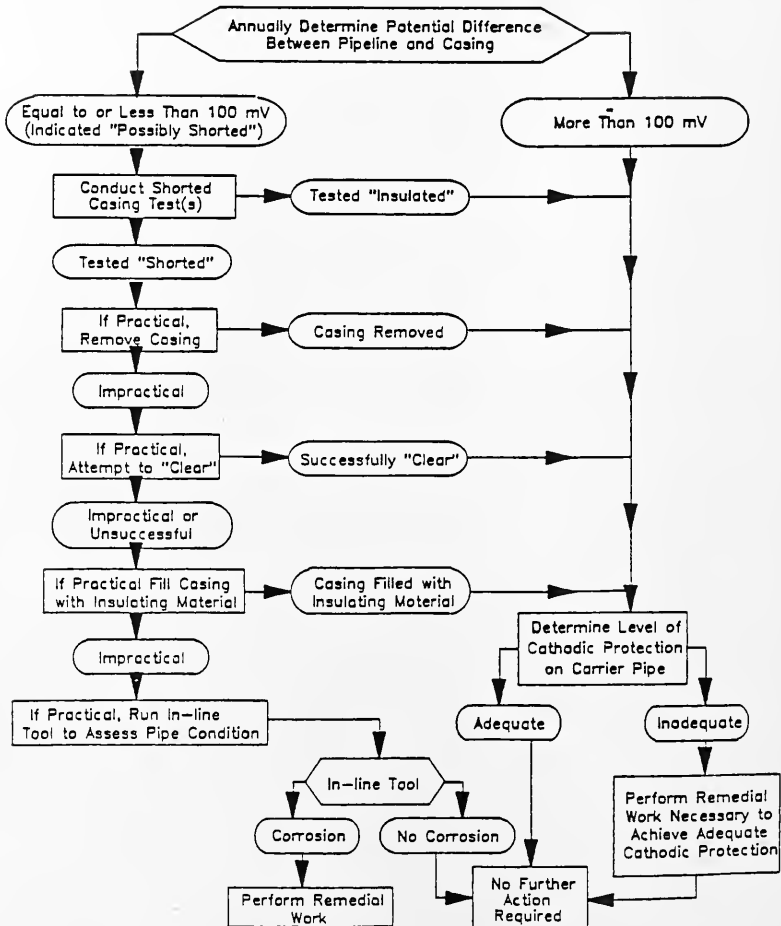
TEXAS EASTERN PRODUCTS PIPELINE COMPANY
CORROSION CONTROL PROGRAM
SHORTED CASING FLOW CHART

Figure 5.--TEPPCO's shorted casing flow chart.
